ENVIRONMENTAL MEMORANDUM

Red Chris Development Company Ltd.
200–580 Hornby Street, Vancouver, BC V6C 3B6

Date: August 11, 2015

Re: Red Chris Monitoring Committee Environmental Report Jul 28 – Aug 11, 2015

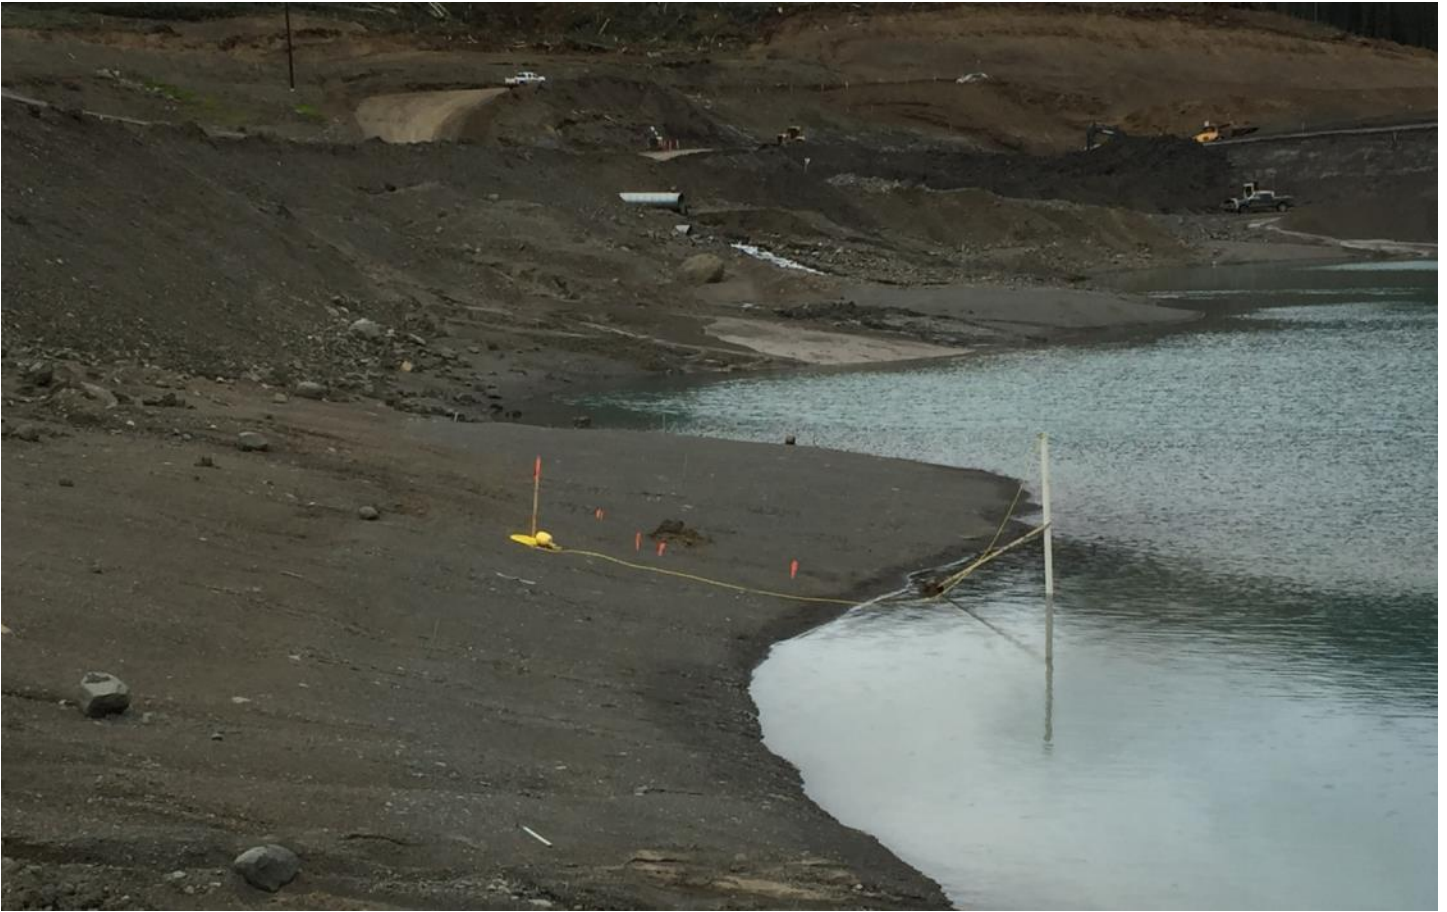
- The transducer for the tailings pond has been reinstalled. With the new set up it should be much easier to recover the data and the transducer when the water level rises too high.
- Bi weekly sampling of the tailings pond, weirs 1 & 2, and W69 have been collected and sent to the lab for analysis.
- Quarterly groundwater samples of 4 wells have been collected and sent to the lab for analysis.
- Water drainage near the crusher on the haul roads has become a problem. A plan for a proper

July 30 The new transducer in the tailings pond.

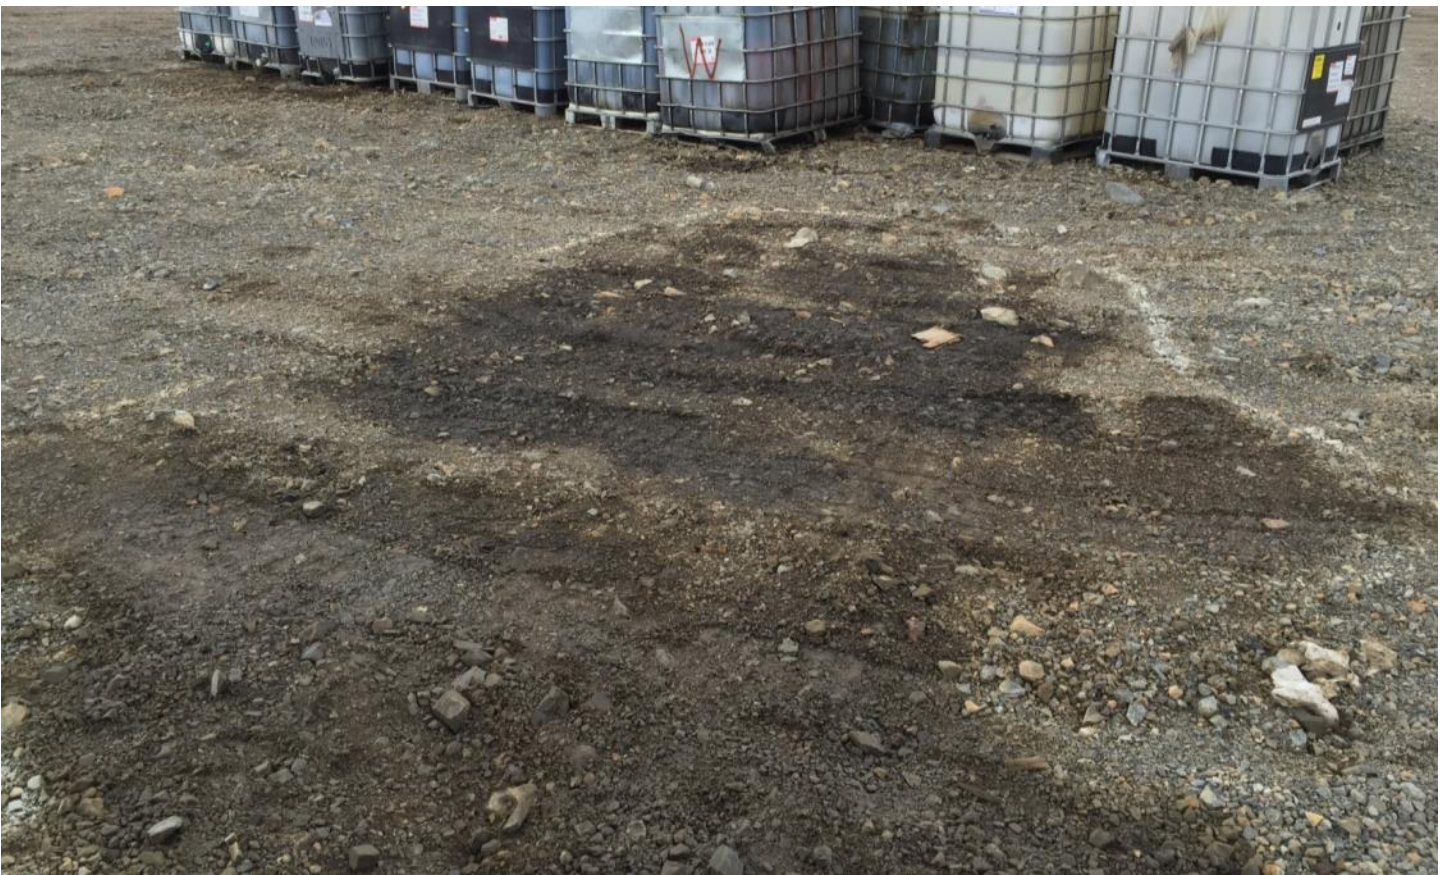
- Site services has collected contaminated soil from around site and deposited it into the new bermed structure. They've especially been busy with the soil at the erection pad where all the waste oil cubes are stored.

July 30 Contaminated soil at the erection pad.

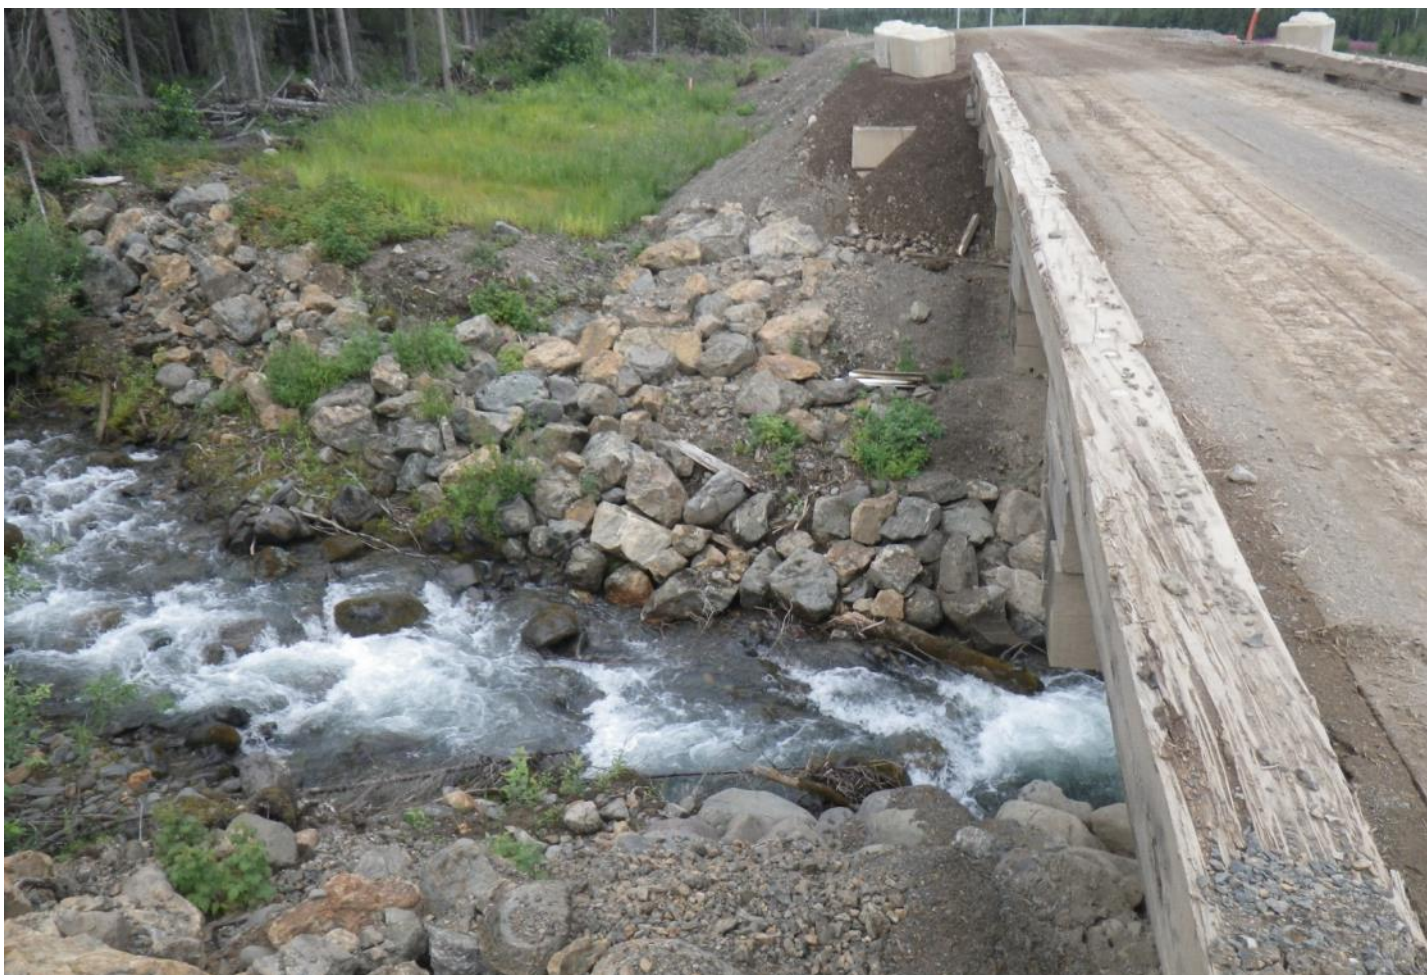
- Water from the large creeks on the main access road at km 0 and 8 had begun to erode away at the bridge abutments. Small gravel and dirt was pulled back and replaced with large rocks to better shield against the water.

July 31 Reworking the abutments at Jackson Creek, near the gate.

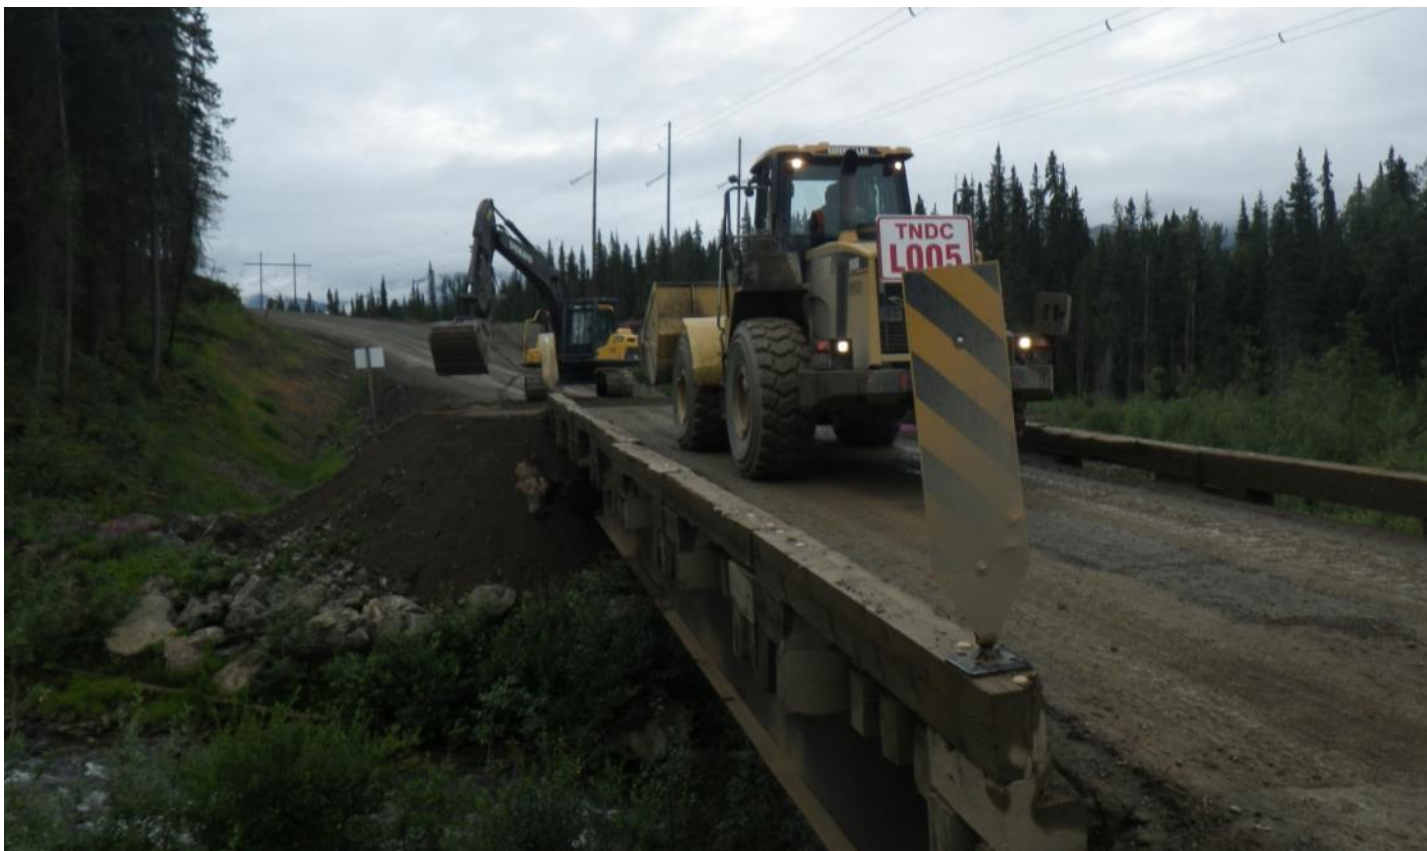
July 31 Reworking the abutments on the bridge at 8km on the main access road.

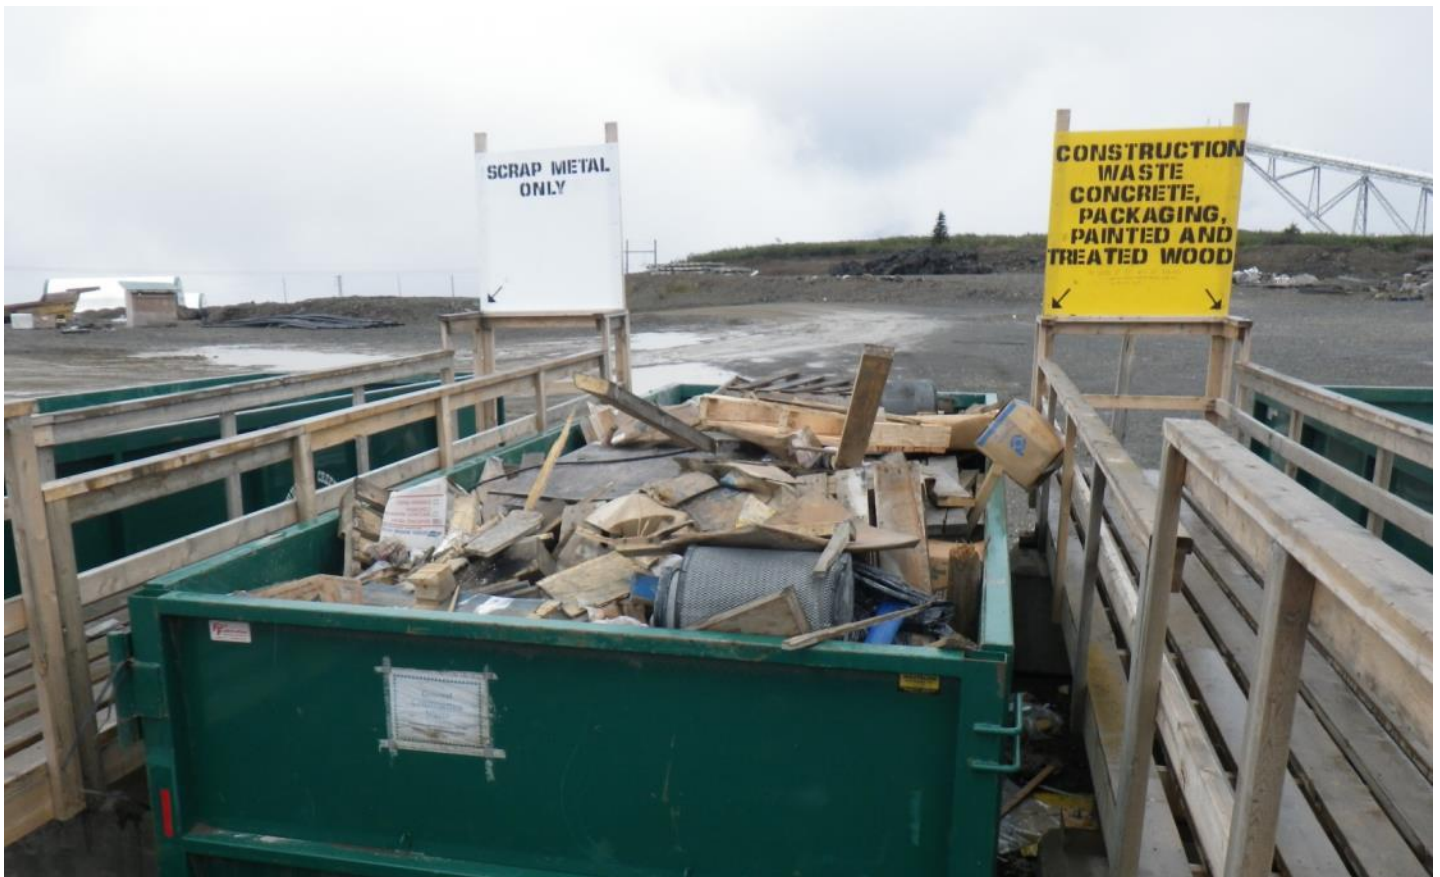
- New signs for waste area have been put up and should help make things clearer for disposing of waste.
- Lots of cardboard and wood had been backed up in the burn pit during the fire ban. When the pit became full people began to deposit wood and cardboard into one of the construction waste bins. As of the 11th of August the bins still haven't been cleaned out.

Aug 2 Wood & cardboard in the construction waste bin the bin was resorted.

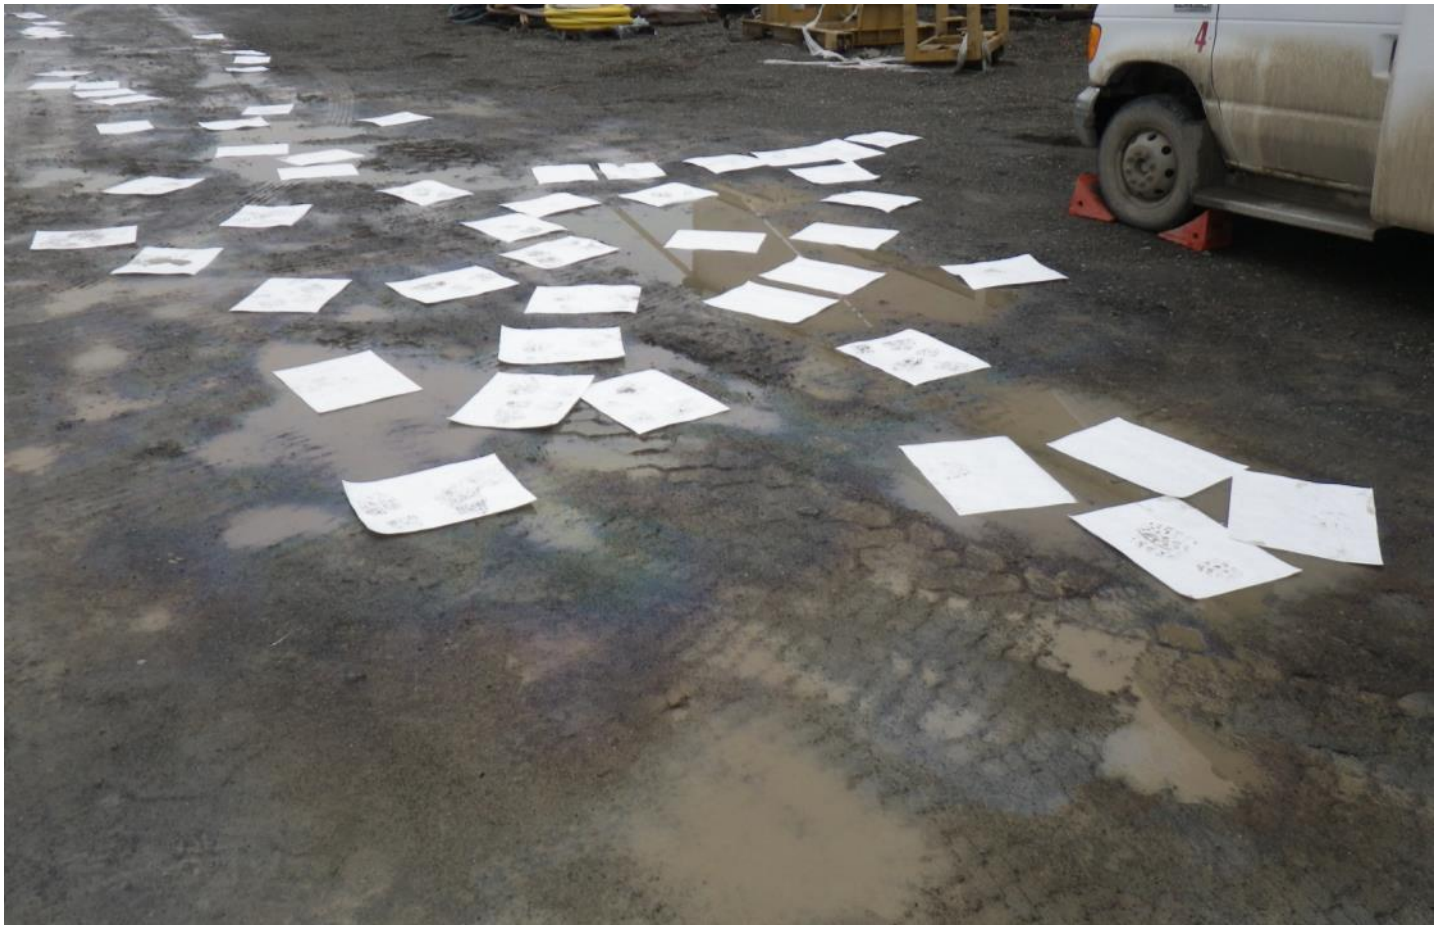
- July 31, 2015; 4L waste oil spill: in maintenance laydown in the TIA. The spill was cleaned up immediately and disposed of properly.
- Aug 3, 2015; motor oil spill: Two septic trucks had begun leaking
- Aug 3, 2015; brake oil spill: a hydraulic hose under the cab of a rock truck had blown spilling approximately 1L in the TIA. Contaminated material was collected and disposed of as per protocol.
- Aug 8, 2015; hydraulic/fuel spill: Approximately 8L leaked out of a stinger truck when it had tipped over. Fortunately, no one was hurt in the incident.

Aug 3 Motor oil spill from the septic truck.

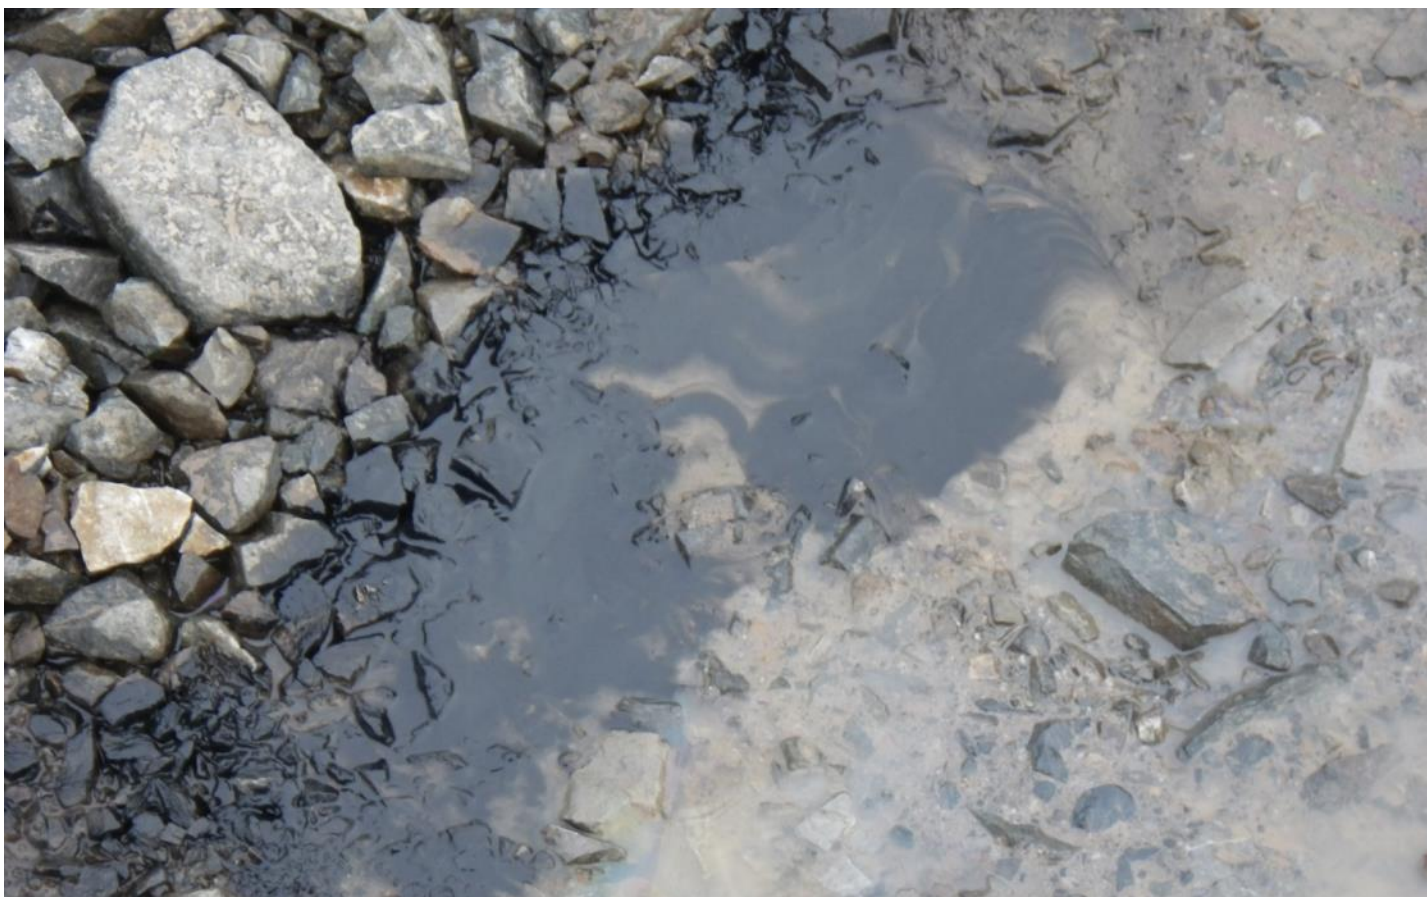
Aug 3 More oil from the septic truck spill.

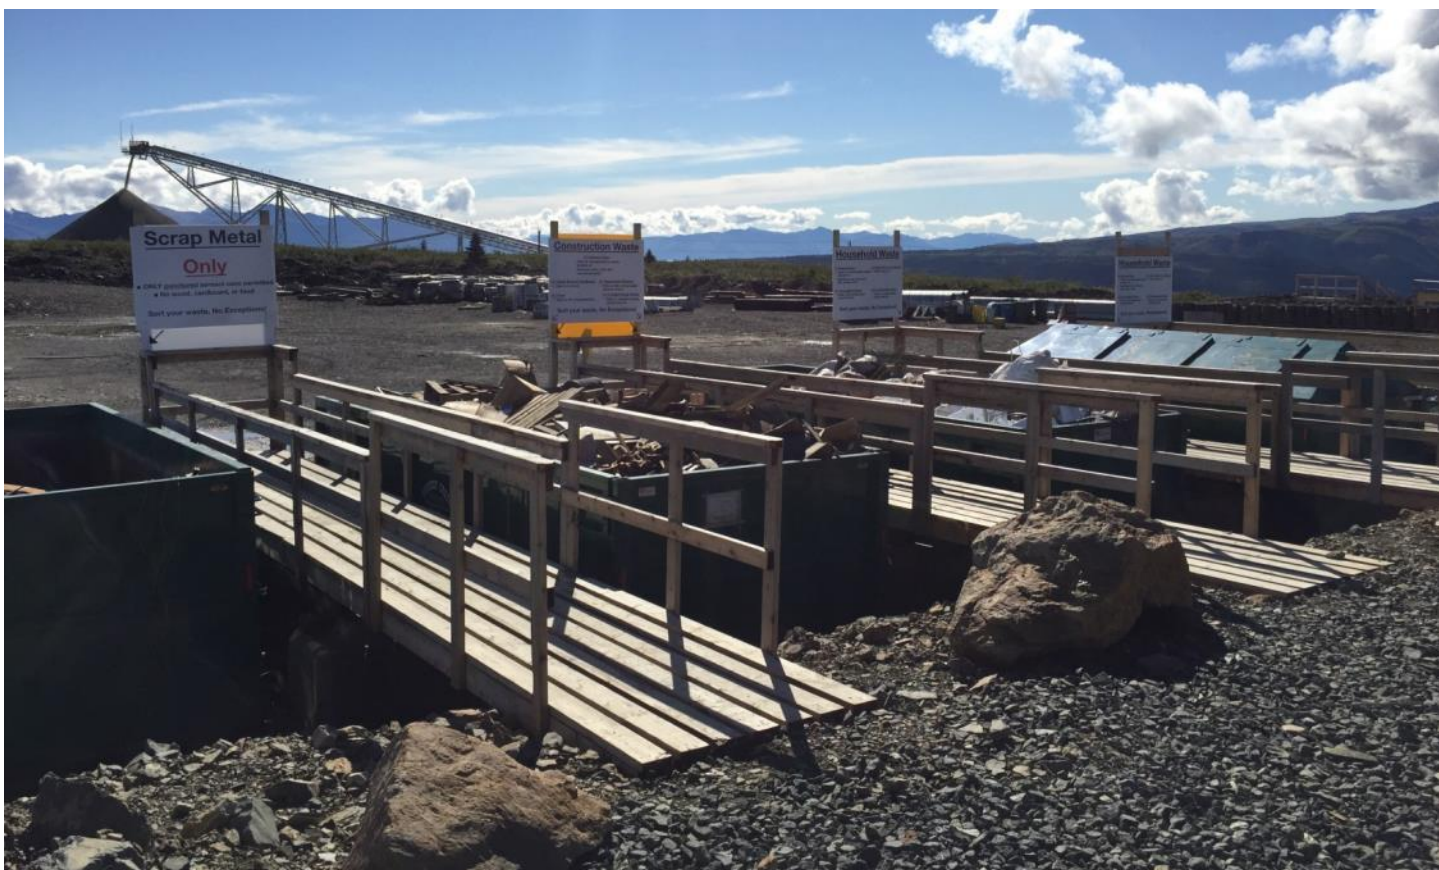
Aug 5 New signs for the waste area.

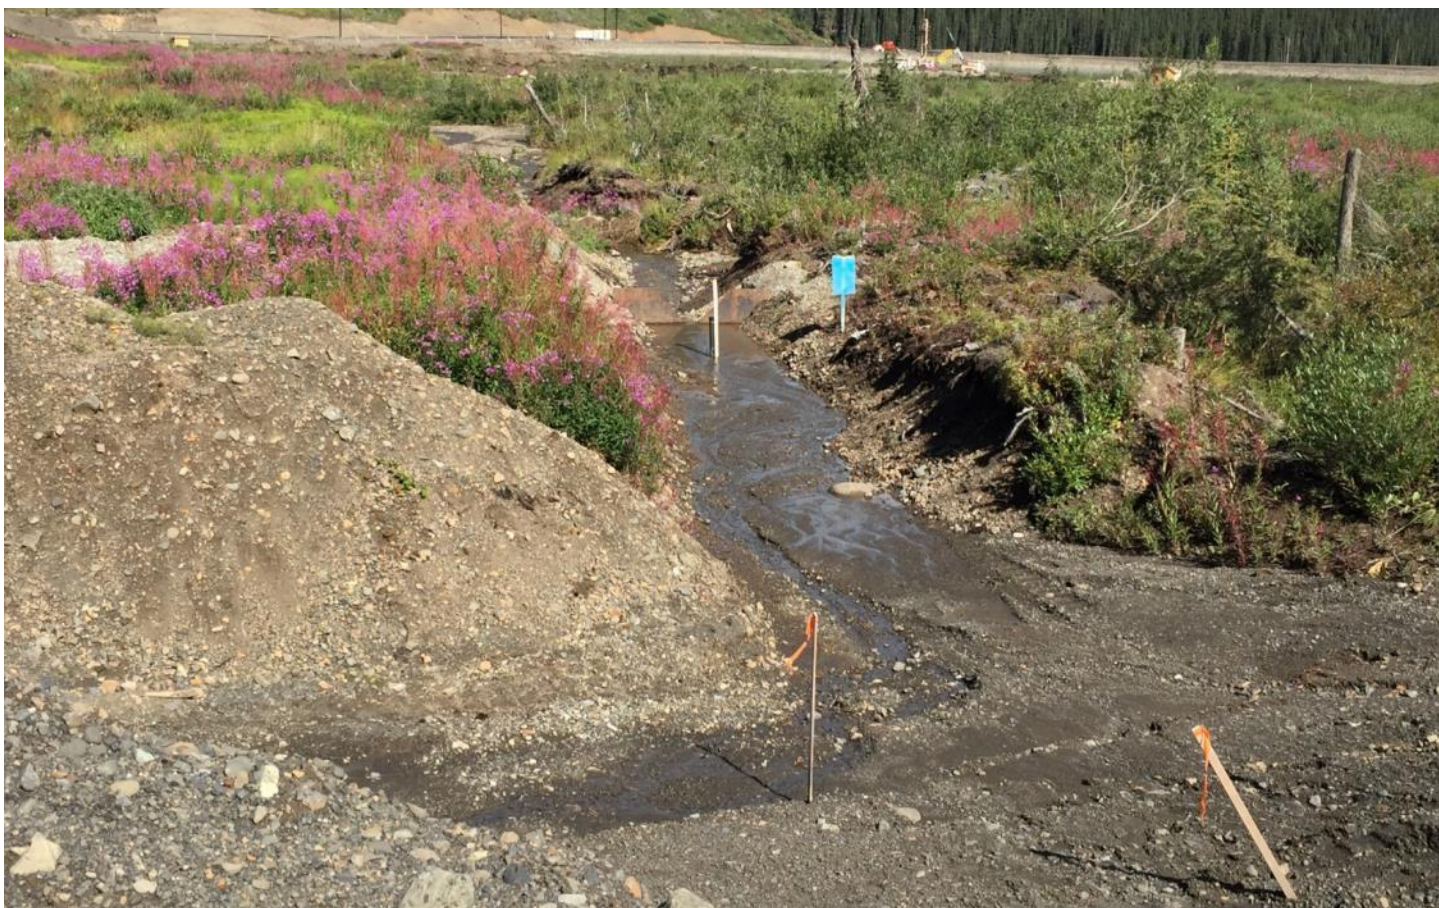
Aug 5 The bentonite and other drill cuttings have been removed form upstream of weir 3.

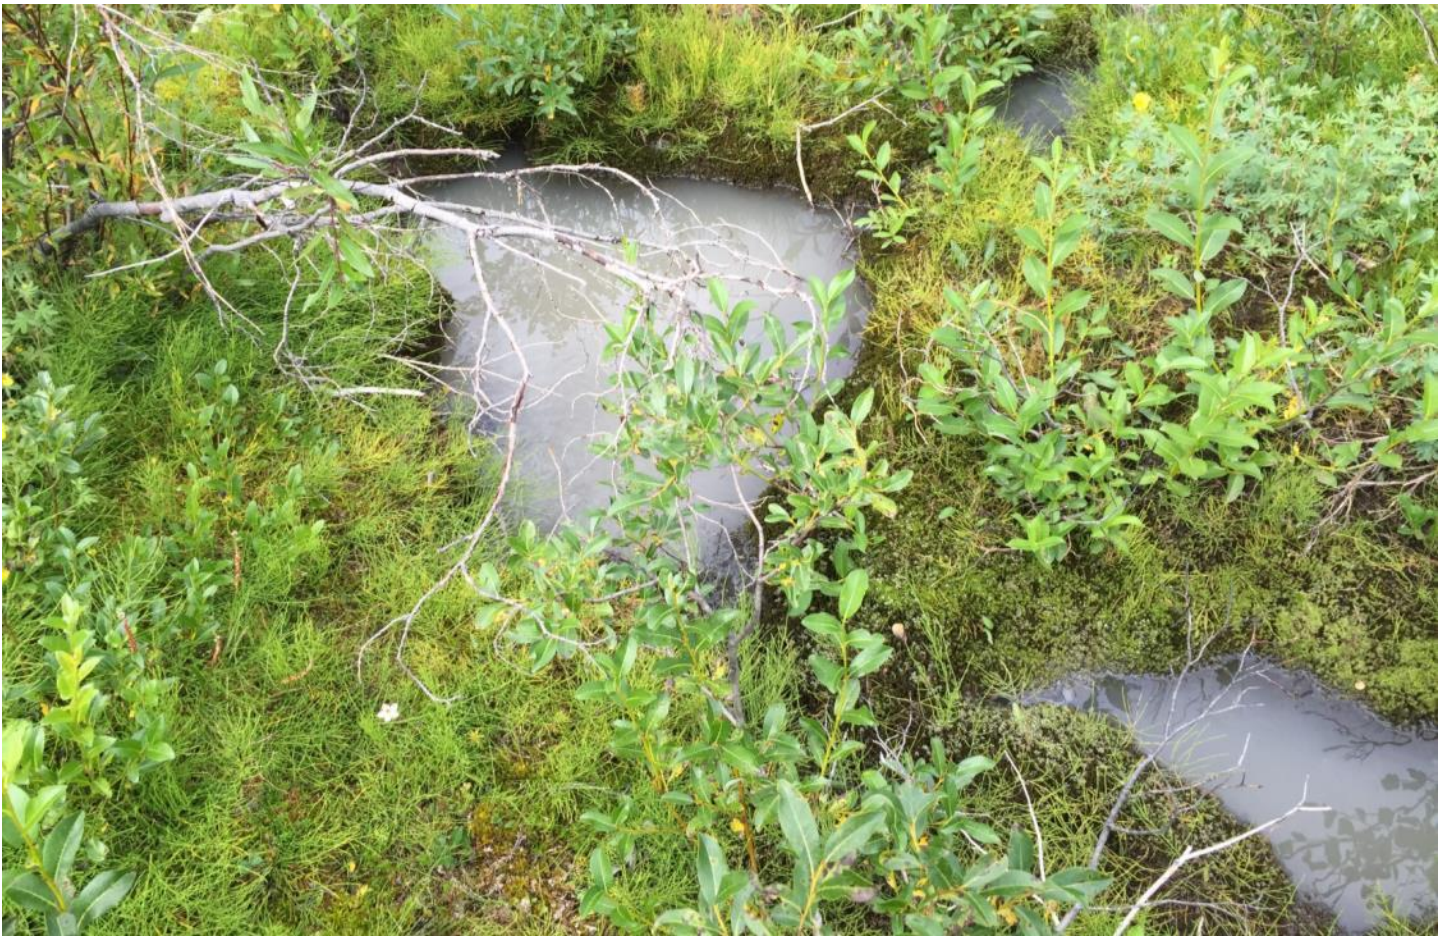
Aug 8 Drill cuttings north of the reclaim dam has made its way downstream into Quarry Creek. Additional sumps and catchments were installed to contain cuttings.

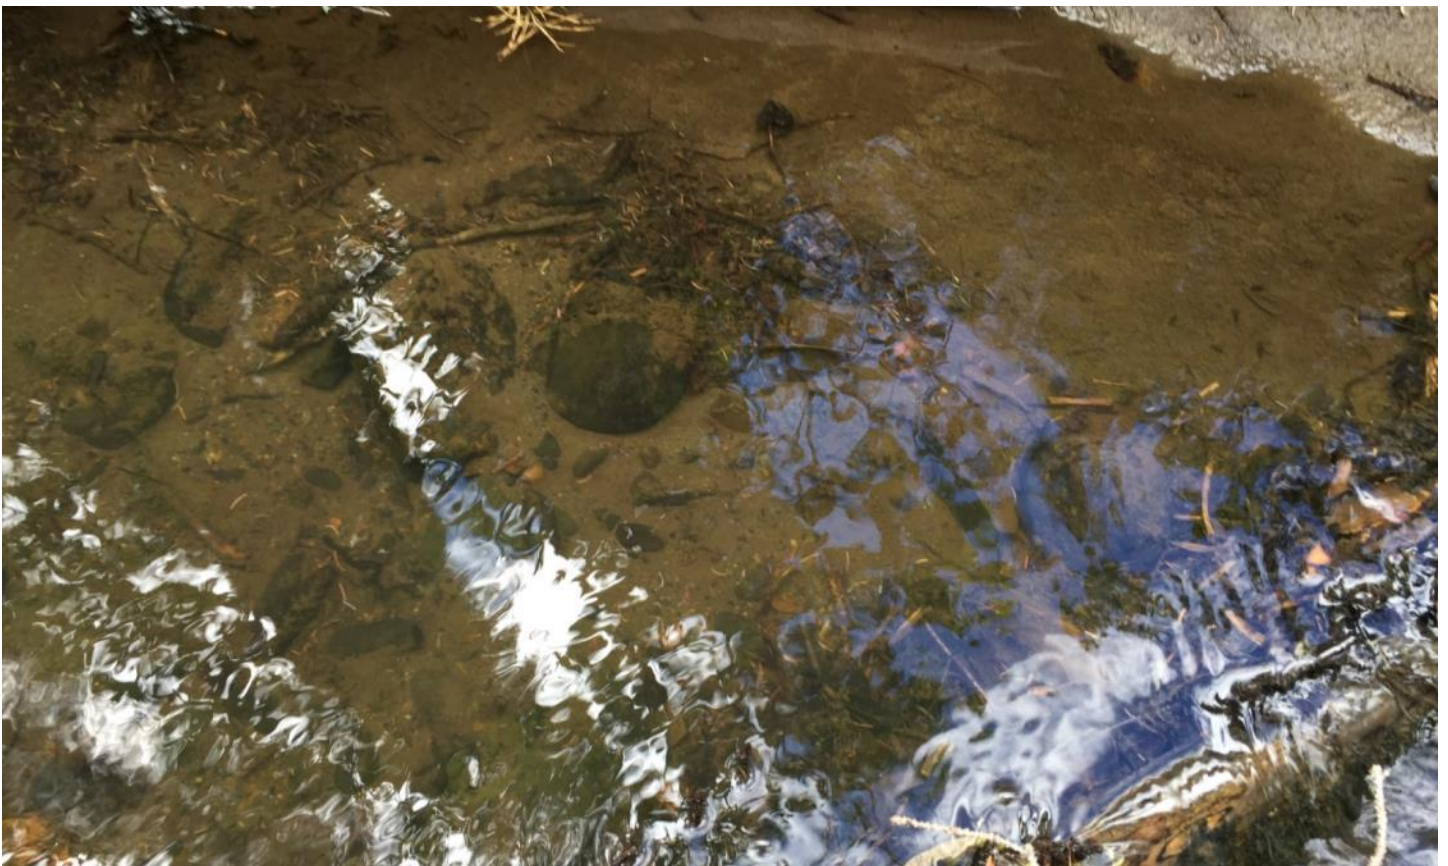
Aug 8 Although it's hard to see in the picture, there is a slight milkiness to the water from the drill cuttings at W69 water sample site.

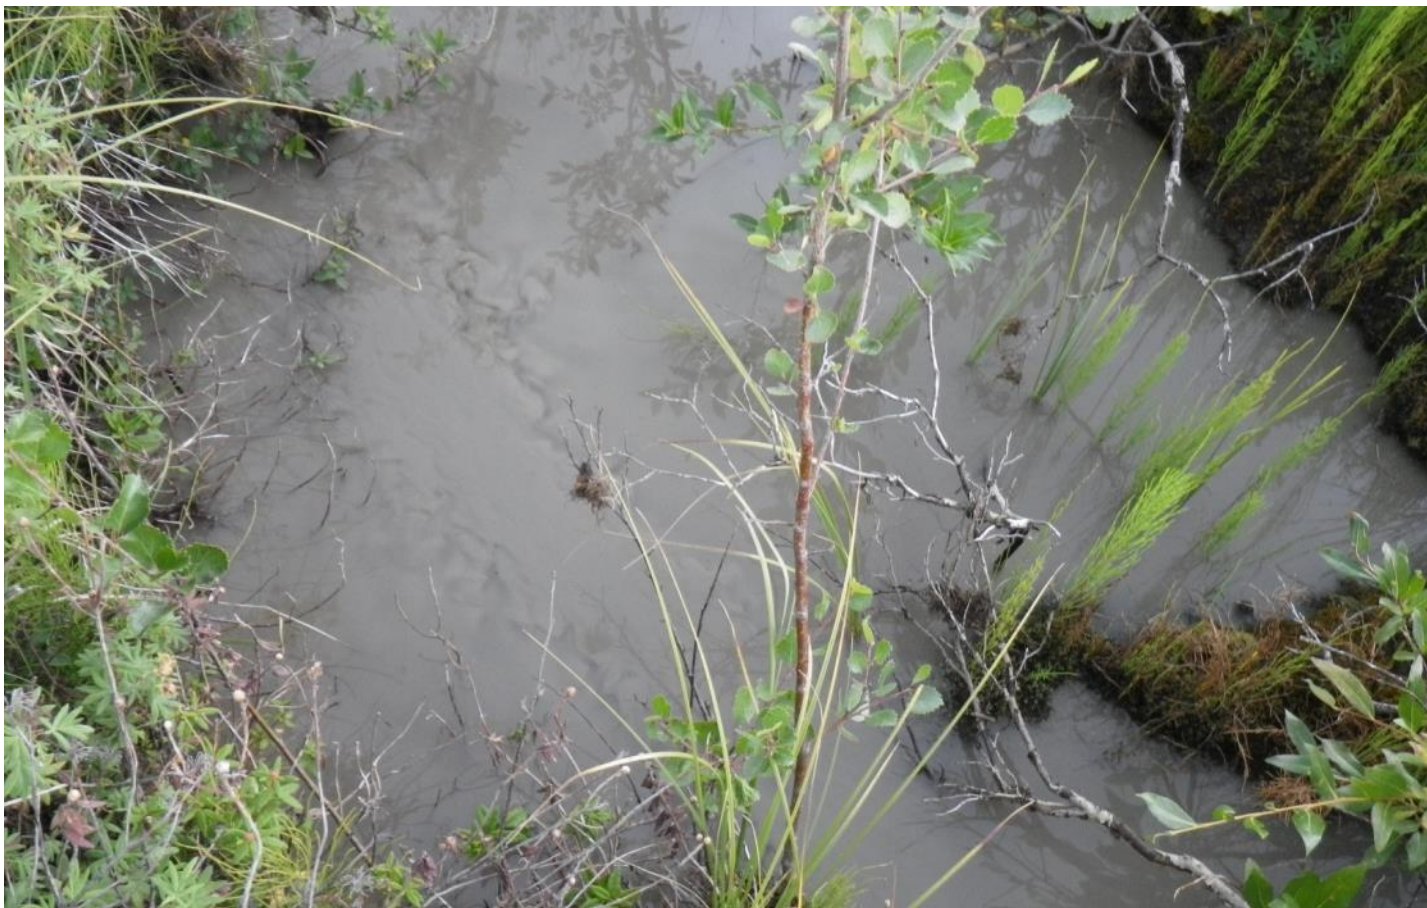
Aug 9 Drill cuttings immediately downstream of the drillers.

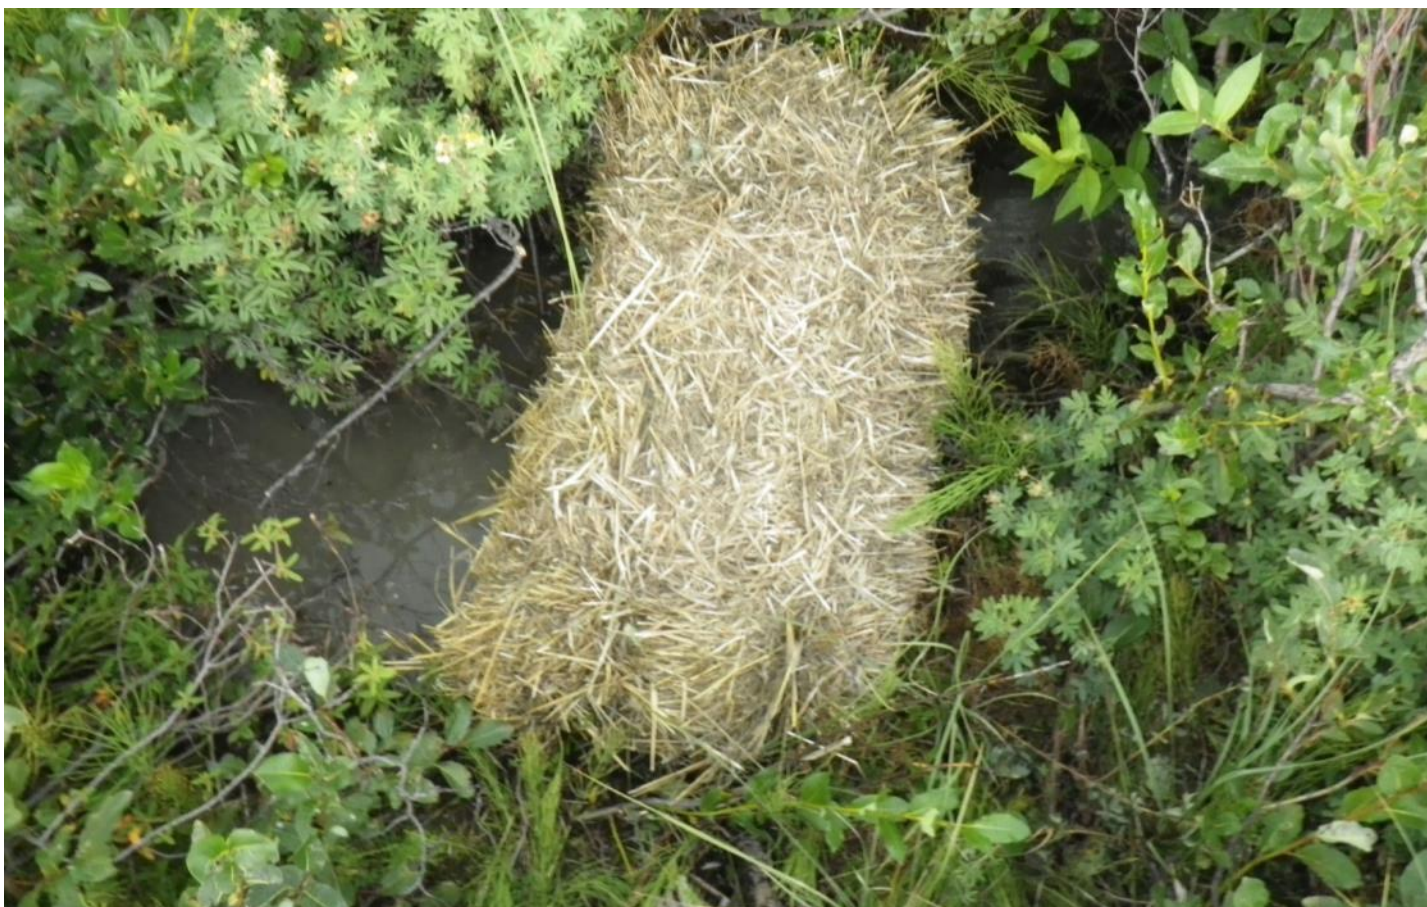
Aug 9 Straw bale check dams have been put into place to help settle out the cuttings from the water.

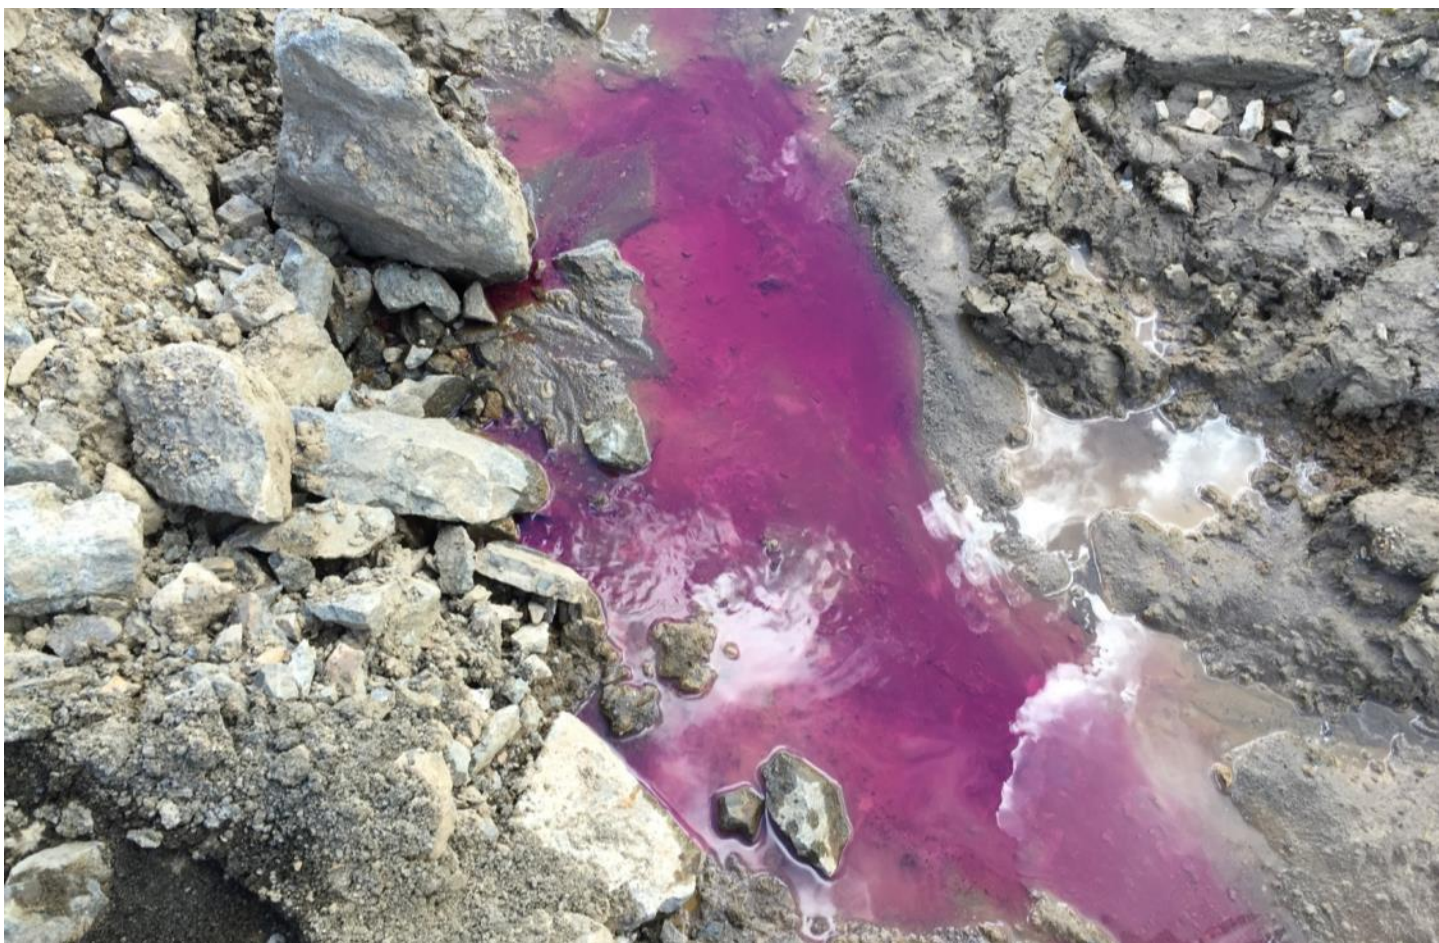
Aug 8 An unknown red substance has somehow mixed with some groundwater that's coming out of the ground behind the drinking water well for the pit shop.

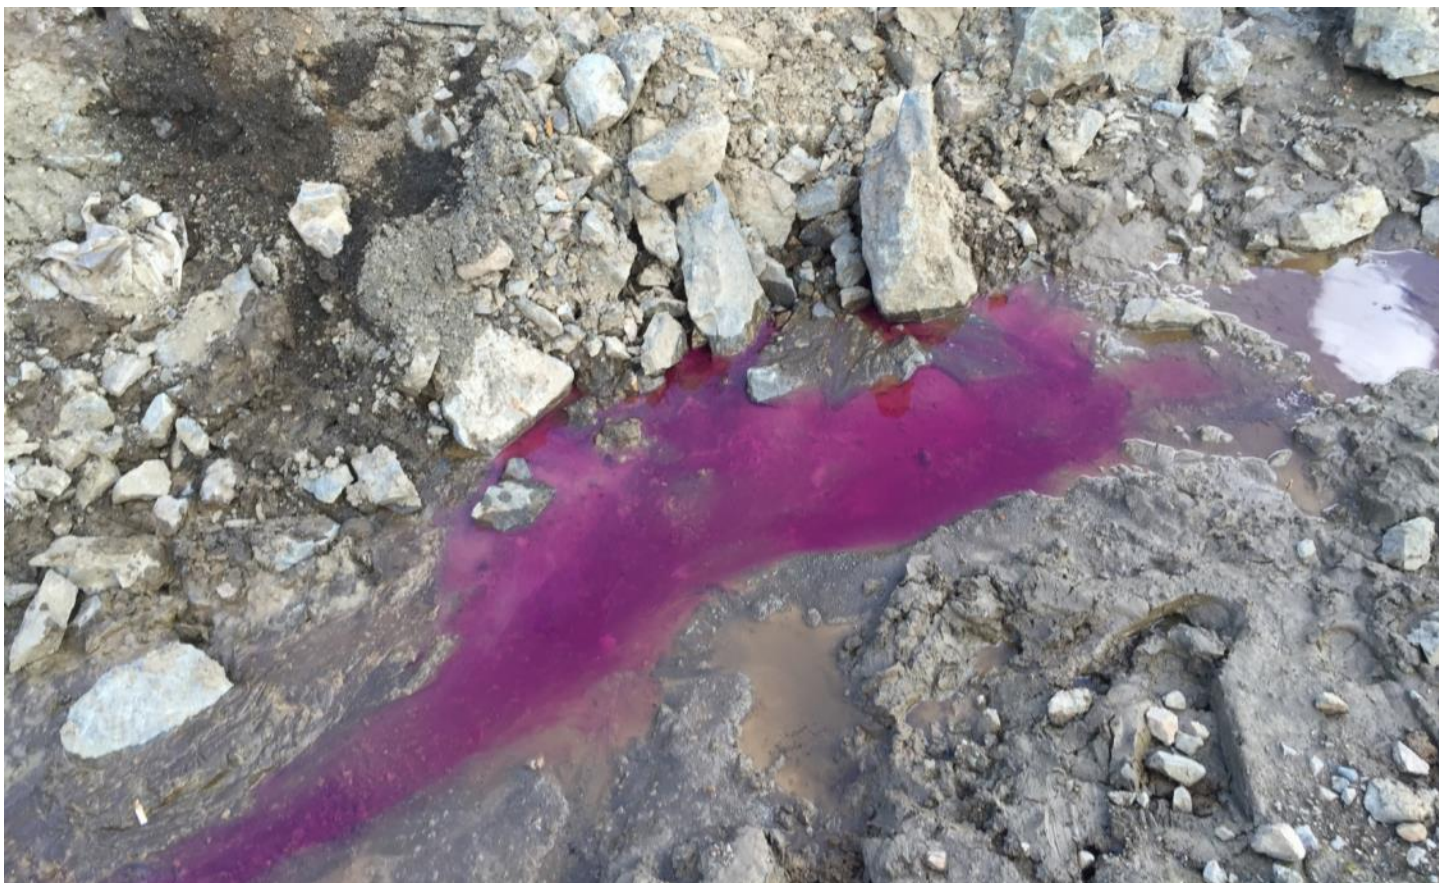
Aug 8 The pink water just ends here and is visible nowhere else.

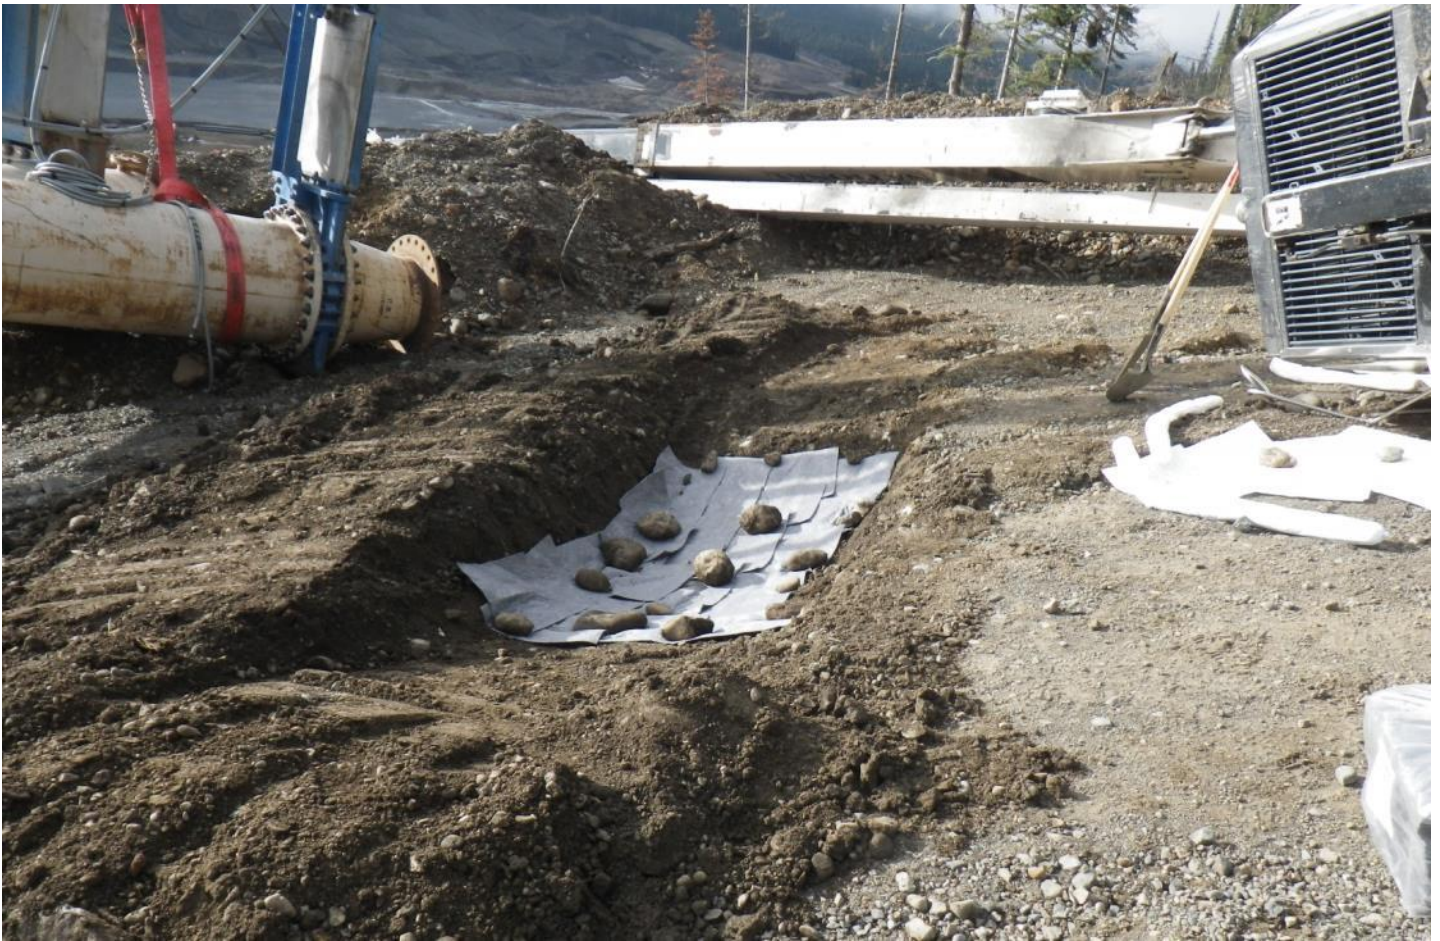
Aug 8 A stinger truck had tipped. A sump for oil had been dug in case a lot of oil was released.

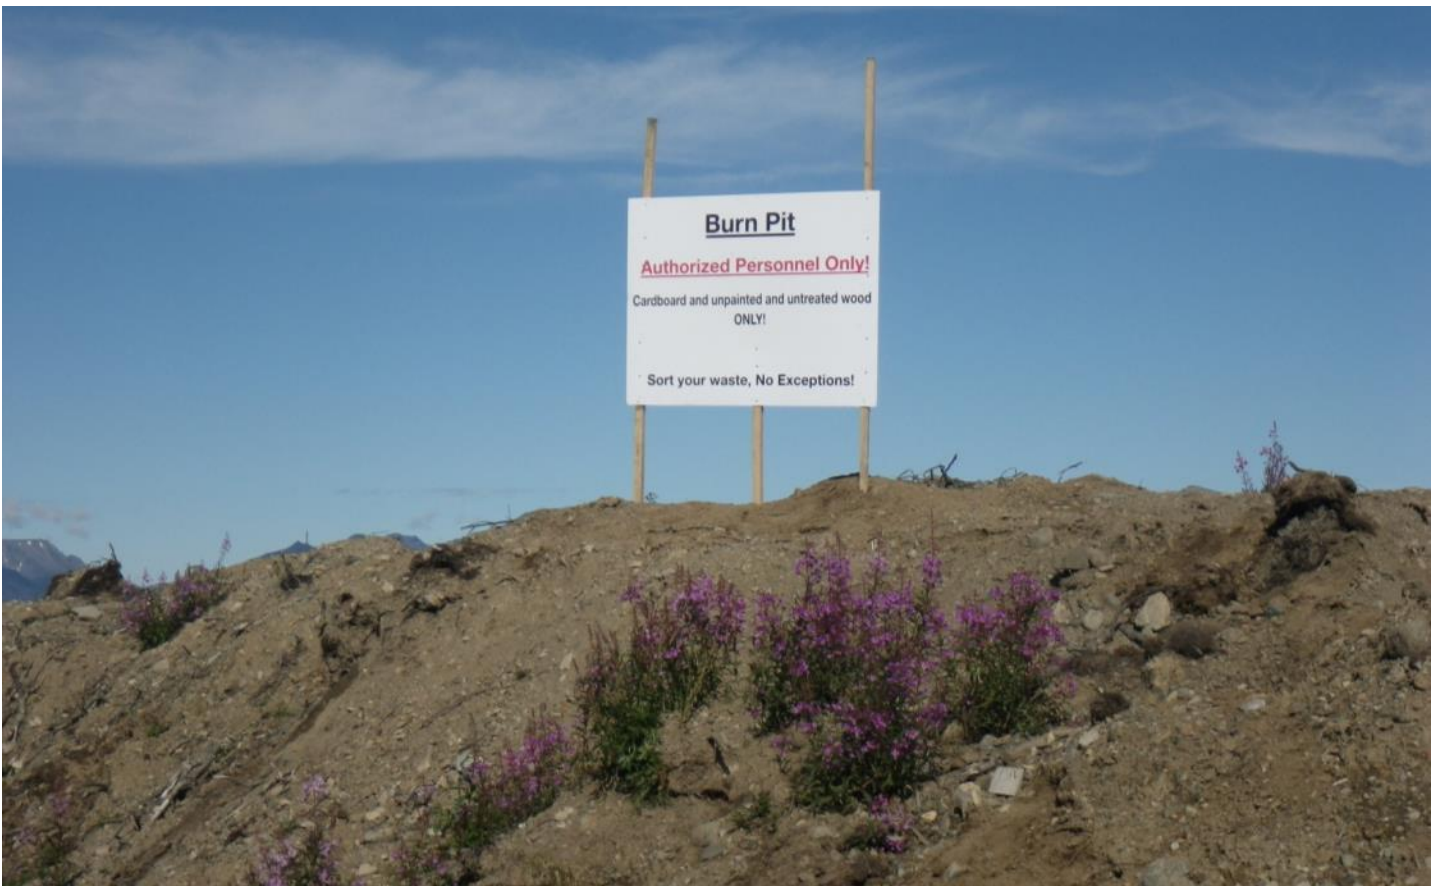
Aug 9 A new sign for the burn pit.
